TEST REPORT

No. : CZIN2303000025CM

Sample Name : SPC FLOORING
Spec. : 1220*183*5mm

Summary of Results:

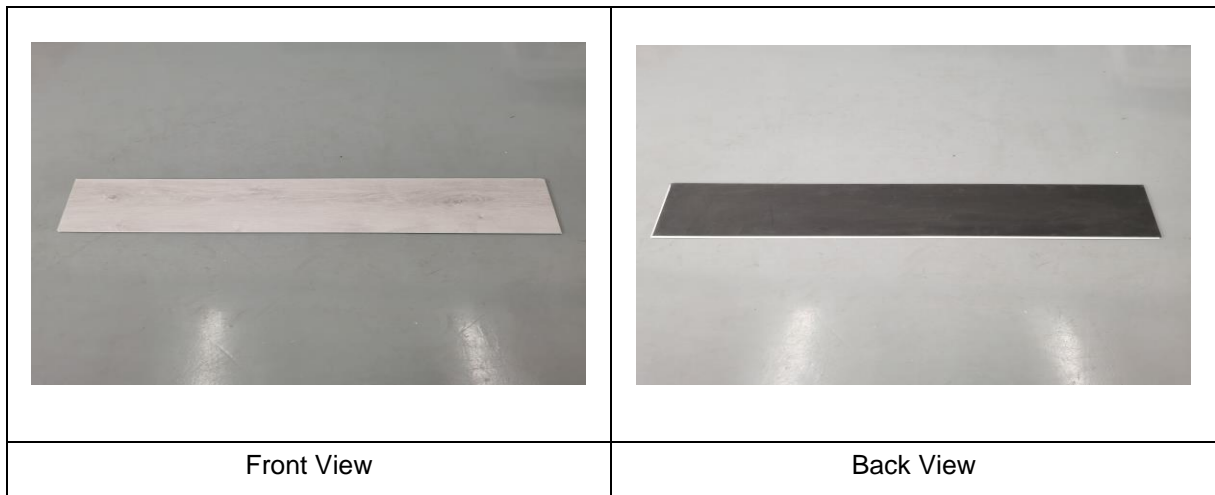
Original Sample Photo(s):

Dimensions	1220mm×183mm×5mm
Surface Density	About 8.41kg/m ²

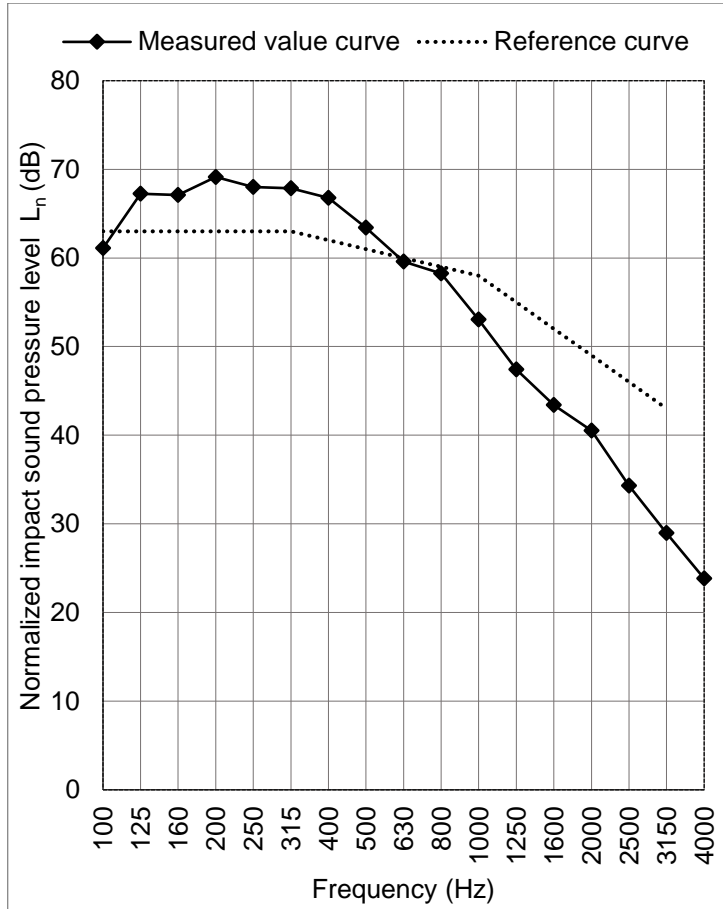
IV. Test Result

Ambient Temperature	15.5°C	Relative Humidity	57.9%RH
Source Room Volume	70m ³	Receiving Room Volume	85m ³
Description of Test Arrangement	Test Area: 11.80m ² (3.87m×3.05m) The test sample is laid directly on the 140mm thick prefabricated floor.

f Hz	L _n dB
100	61.1
125	67.3
160	67.1
200	69.1
250	68.0
315	67.8
400	66.8
500	63.4
630	59.6
800	58.3
1000	53.1
1250	47.4
1600	43.4
2000	40.5
2500	34.3
3150	28.9
4000	23.8
5000	/

L_{n,w} = 61dB, C₁ = 0dB

Note: L_{n,w} is the weighted normalized impact sound pressure level, based on the test performed with an artificial source under laboratory conditions (engineering method) with the specified reference floor.

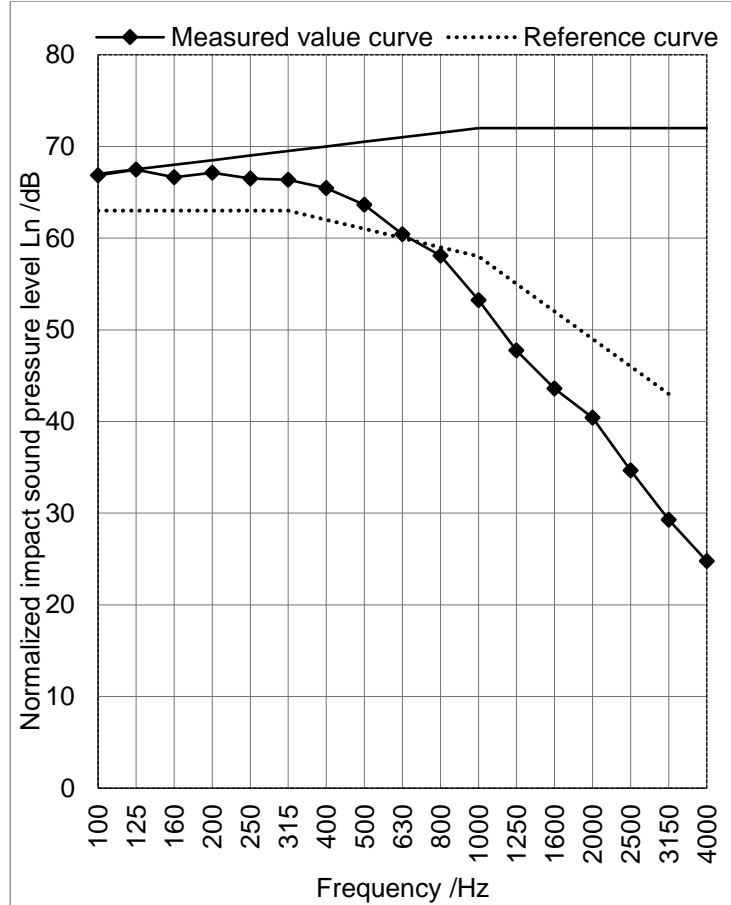
IV. Test Result

Ambient temperature	15.5°C	Relative humidity	57.9%RH
The source room Volume	70m ³	The receiving room Volume	85m ³
Description of test arrangement	Test Area: 11.80m ² (3.87m×3.05m) The test sample is laid directly on the 140mm thick prefabricated floor.

f Hz	$L_{n,r,0}$ dB	$L_{n,r}$ dB	ΔL dB
100	67.0	66.8	0.2
125	67.5	67.5	0.0
160	68.0	66.6	1.4
200	68.5	67.1	1.4
250	69.0	66.5	2.5
315	69.5	66.4	3.1
400	70.0	65.4	4.6
500	70.5	63.6	6.9
630	71.0	60.4	10.6
800	71.5	58.1	13.4
1000	72.0	53.2	18.8
1250	72.0	47.7	24.3
1600	72.0	43.6	28.4
2000	72.0	40.4	31.6
2500	72.0	34.7	37.3
3150	72.0	29.3	42.7
4000	72.0	24.8	47.2
5000	/	/	/

$L_{n,r,w} = 61\text{dB}$, $\Delta L_w = 17\text{dB}$, $C_{i,r} = 0\text{dB}$, $C_{i,\Delta} = -11\text{dB}$

Note: $L_{n,r,w}$ is the weighted normalized impact sound pressure level, ΔL_w is the weighted reduction impact sound pressure level, based on the test performed with an artificial source under laboratory conditions (engineering method) with the specified reference floor.

$C_{i,r}$ is the spectrum adaptation term for $L_{n,r,w}$, $C_{i,\Delta}$ is the spectrum adaptation term for ΔL_w . In the case of the actual sound source impact, the corresponding spectrum correction should be added.
