Test Report No. SHAMLC2214176901 Date: 26 Oct 2022 Page 1 of 3

Sample Name : SPC FLOORING
Product Specification : 1220*181*8.5mm

Formaldehyde Emission

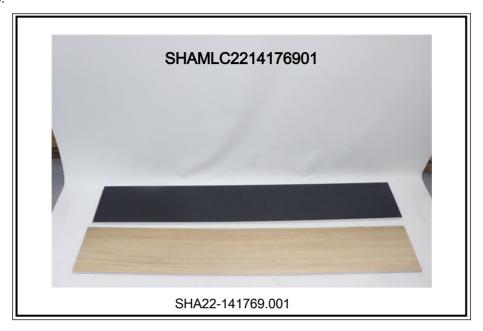
Sample photo:

SN₁ SHA22-141769.001 Yellow/black/white solid board
